PROPERTY CONDITION INSPECTION

Reference: BDI1324 Issue N° 1

Project: Project C
Project Address

Site Surveyed: Site C
Site Address

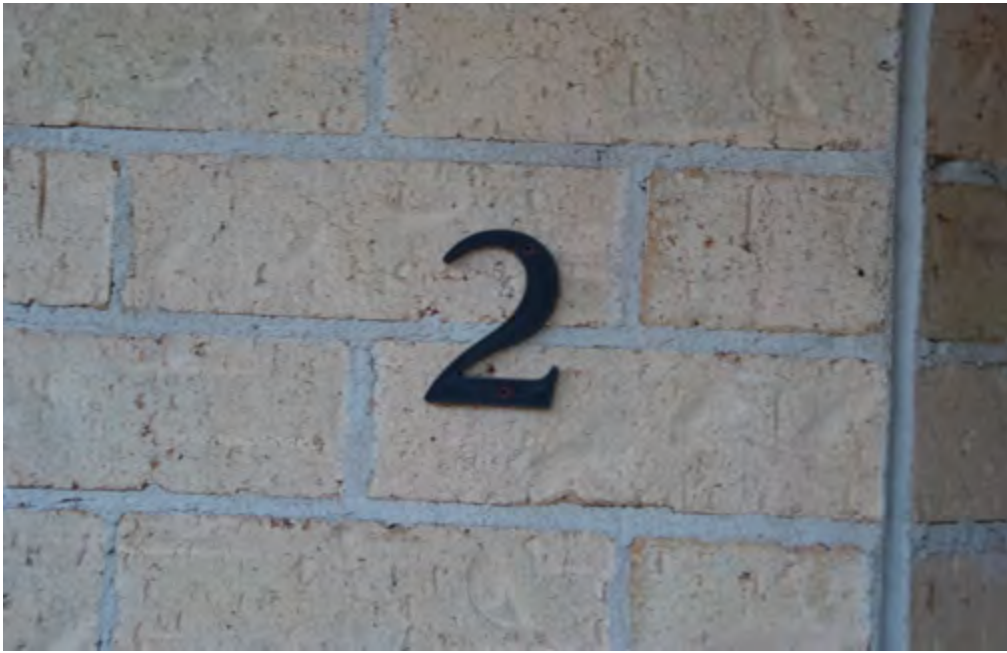
Figure: 0001

1234 SAMPLE ROAD

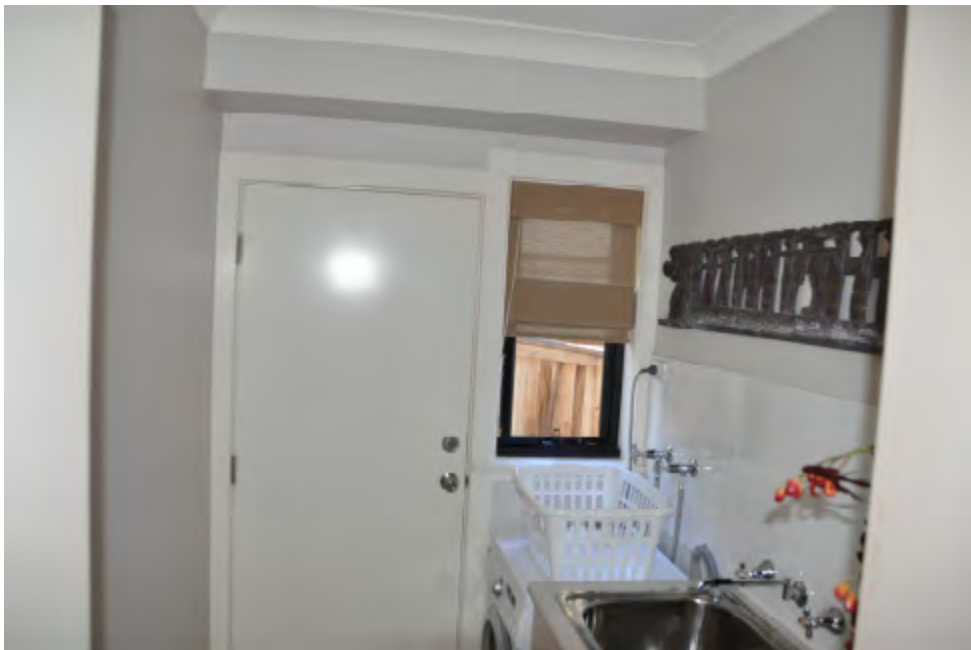
Figure: 0002

General view in the laundry.

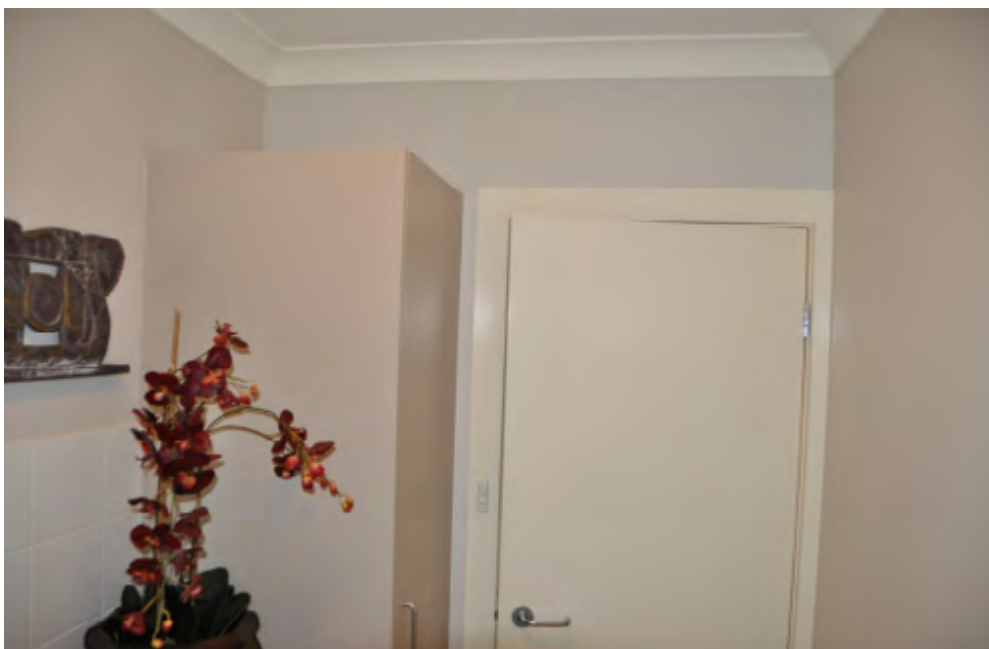
Figure: 0003

General view in the laundry.

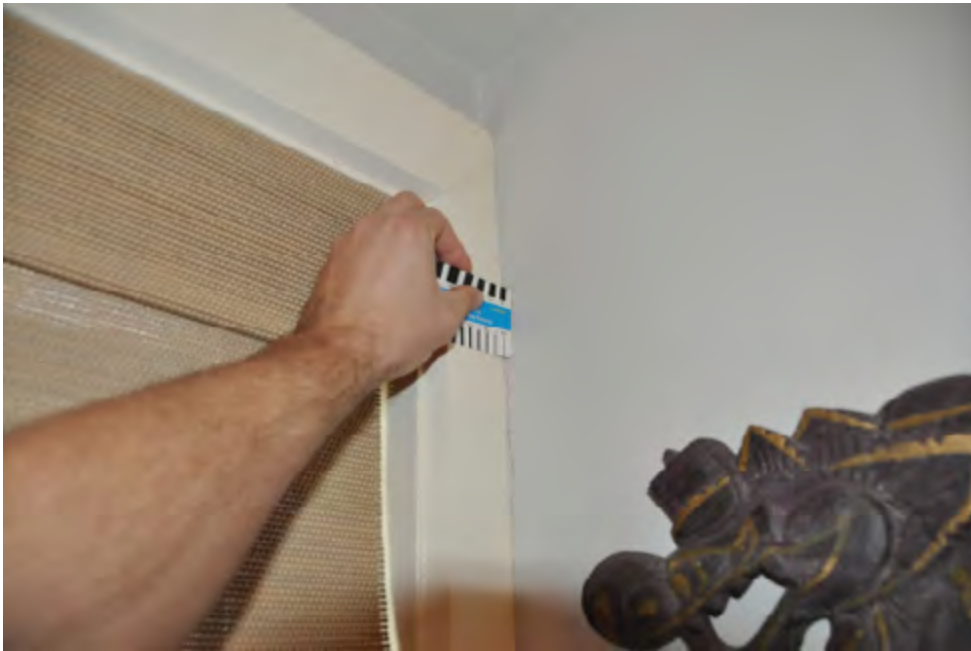
Figure: 0004

1. 0.5mm cracking in the front right corner of the laundry. See photo 4
2. 1.0mm cracking in the front right corner of the laundry. See photo 5
3. 1.5mm cracking in the front right corner of the laundry. See photo 6
4. 0.5mm cracking above the door to bedroom 1. See photo 7
5. 1.0mm cracking in the rear right corner of bedroom 1 en suite. See photo 8
6. 0.5mm cracking in the tile paving on the rear side of the swimming pool extending over 2.5 tiles. See photo 9

0.5mm cracking in the front right corner of the laundry.

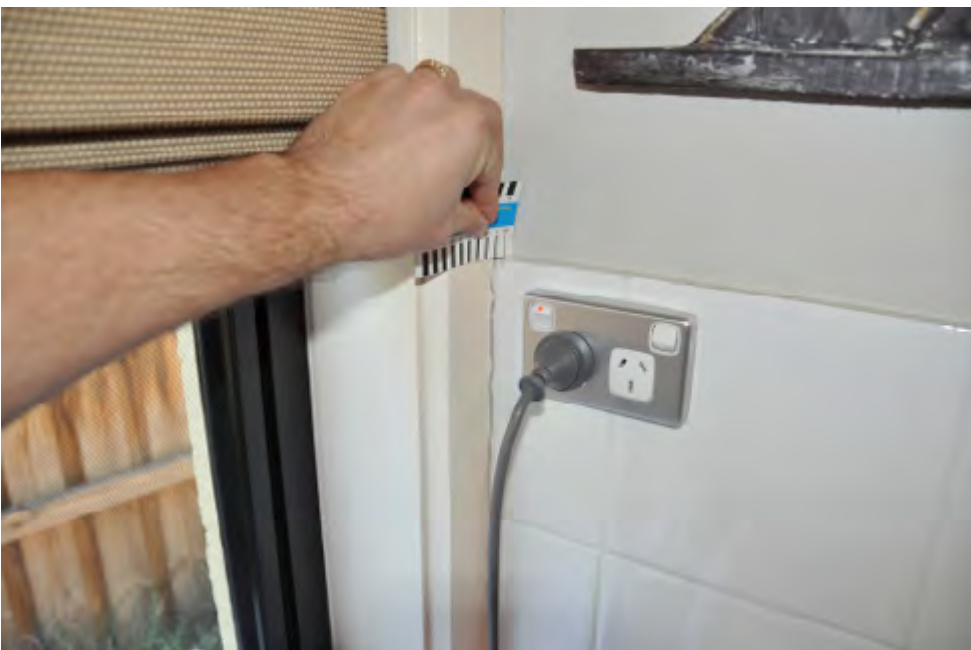
Figure: 0005

1.0mm cracking in the front right corner of the laundry.

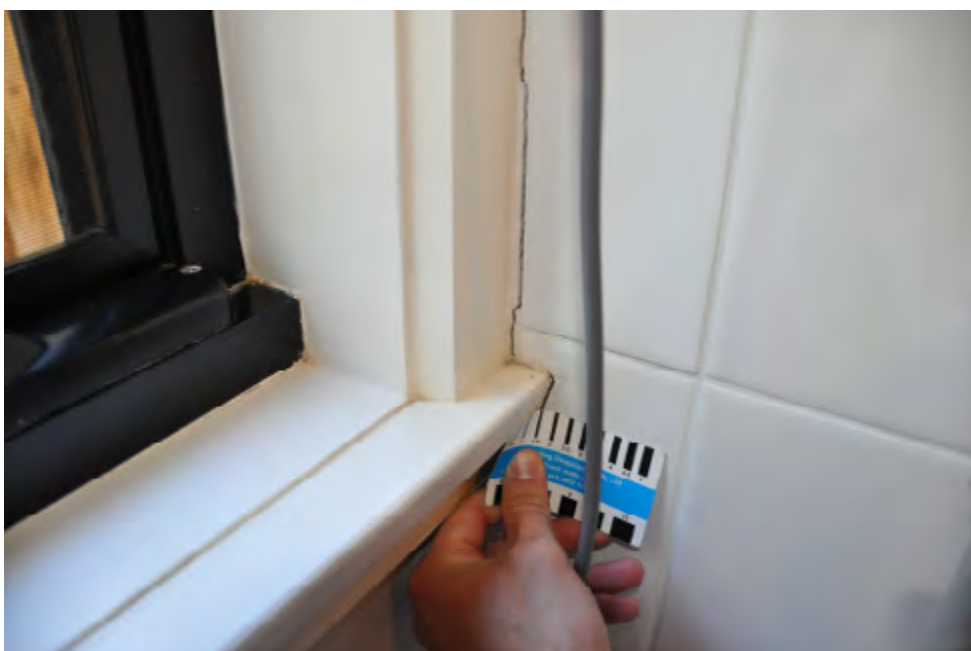
Figure: 0006

1.5mm cracking in the front right corner of the laundry.

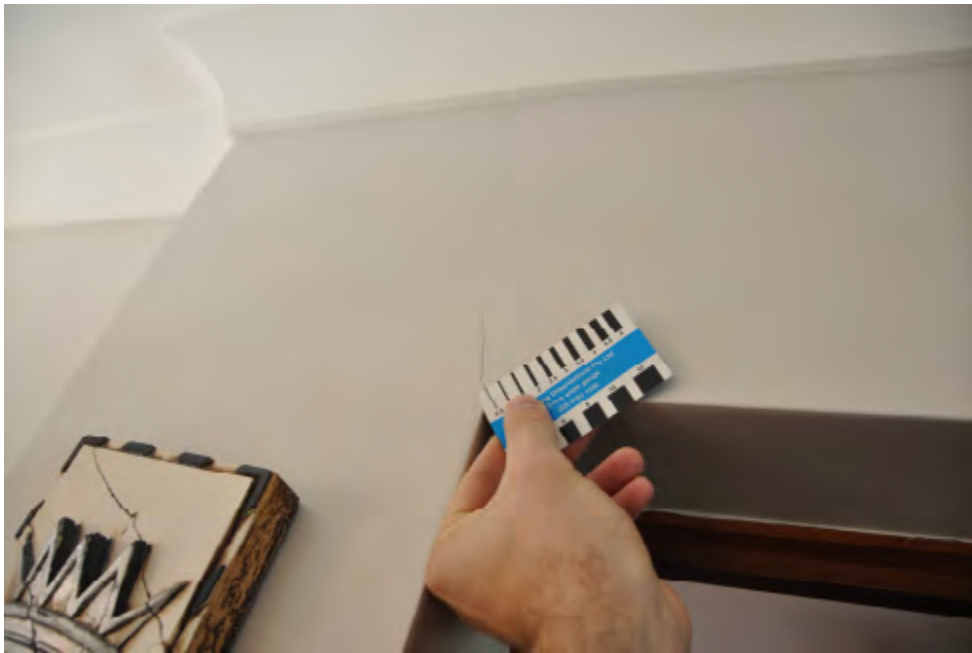
Figure: 0007

0.5mm cracking
above the door to
bedroom 1.

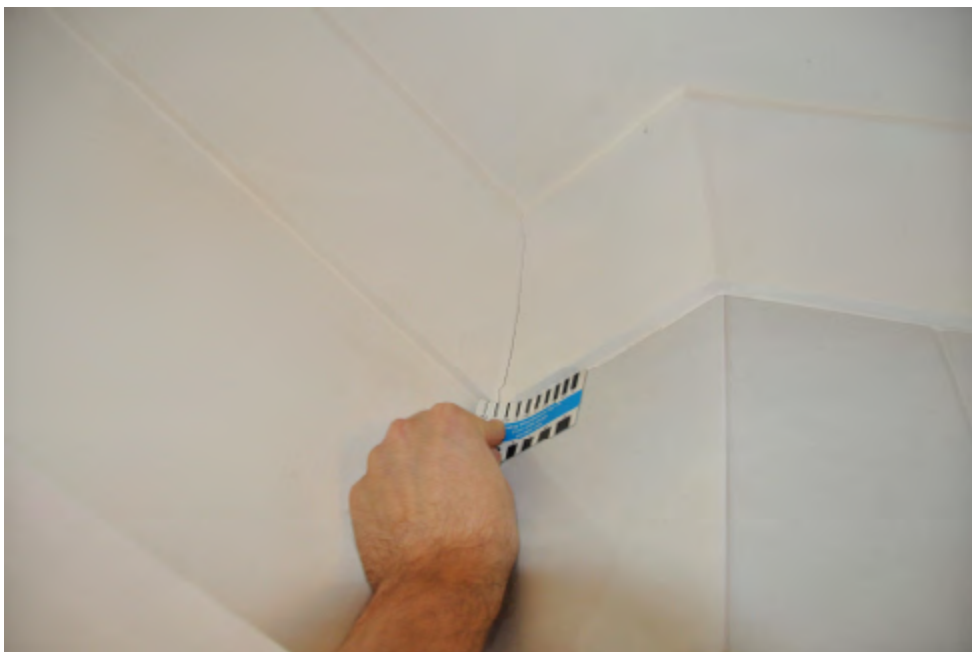
Figure: 0008

1.0mm cracking in
the rear right corner
of bedroom 1 en
suite.

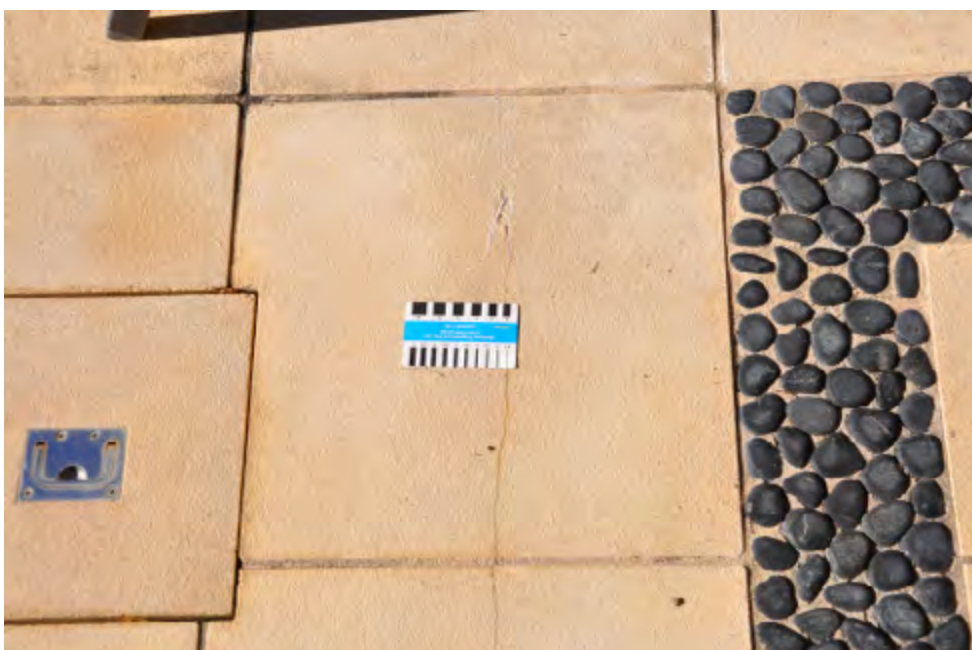
Figure: 0009

0.5mm cracking in
the tile paving on the
rear side of the swim-
ming pool extending
over 2.5 tiles.
